September 17, 2026

Railroad Investigation Report RIR-26-15

# Prohibit Riding Railroad Equipment During Shoving Movements

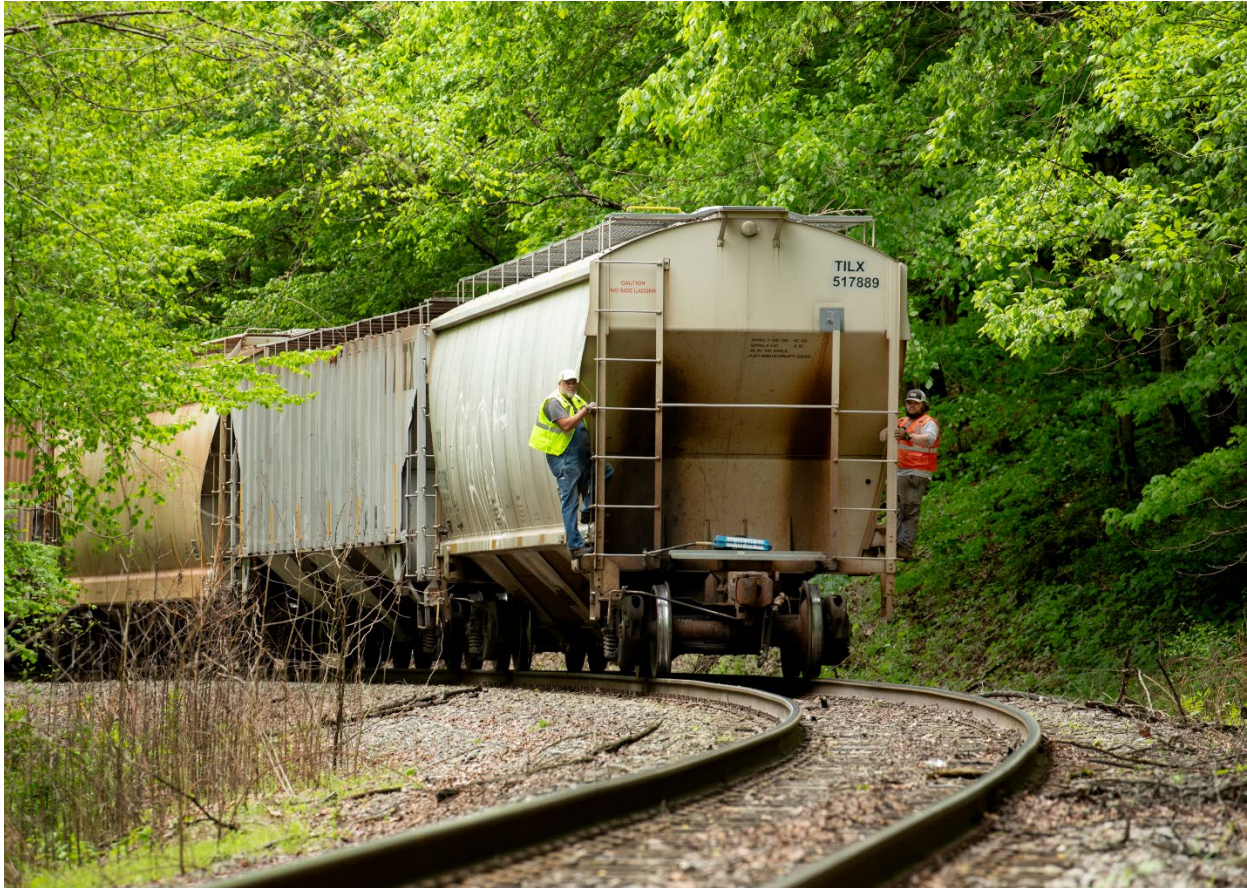
of rail equipment. The riding equipment method of point protection exposes employees to unacceptable risk. Since October 2020, 16 NTSB accident investigations have involved an employee riding equipment while protecting a shoving movement. In 14 of the accidents, the employee was fatally injured, and in two, the employee was seriously injured.

**Figure 1.** Railroad employees ride the side of a railcar. (Photo: Chase Gunnoe, *Trains Magazine*.)

Prohibit railroads from allowing employees to provide point protection by riding equipment during shoving movements. (R-26-12)

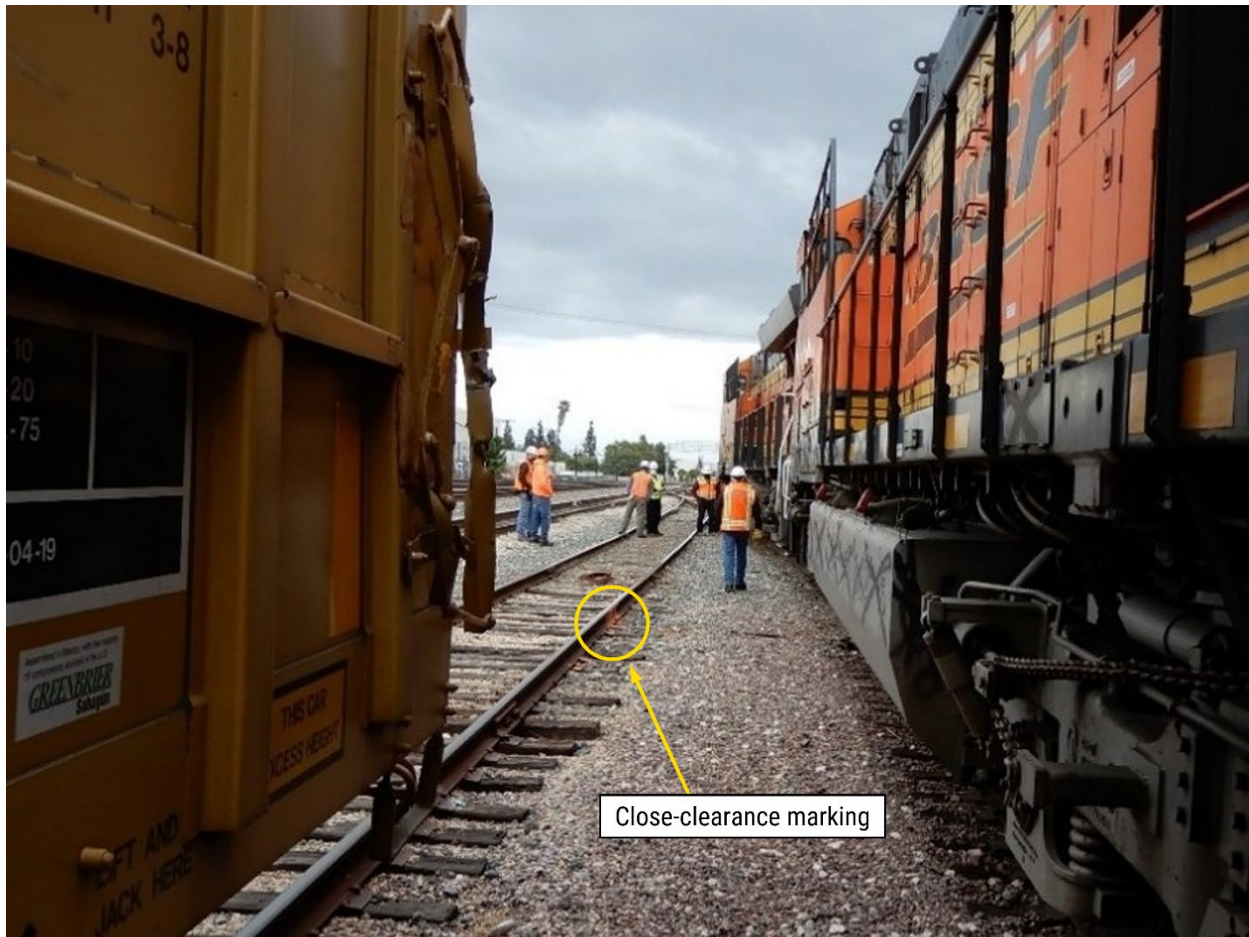
**Figure 2.** A marked close-clearance area in the La Mirada, California, accident investigation.

Shoving movements that pass through locations with close clearances can cause conductors to be pinned or crushed, as in a 2021 accident in La Mirada, California, in which a BNSF Railway (BNSF) conductor was fatally injured when he was pinned between the boxcar he was riding and a locomotive parked on an adjacent track. The close-clearance area was marked, but our investigation found the markings were difficult for the conductor to see from his vantage point on the railcar. In a 2023 accident in Cumberland, Maryland, a CSX Transportation (CSX) conductor trainee was fatally injured when he passed through a temporary close clearance during a shoving movement and was caught between the railcar he was riding and a parked locomotive. The close clearance existed only when equipment was stored on the adjacent track; it was not marked.

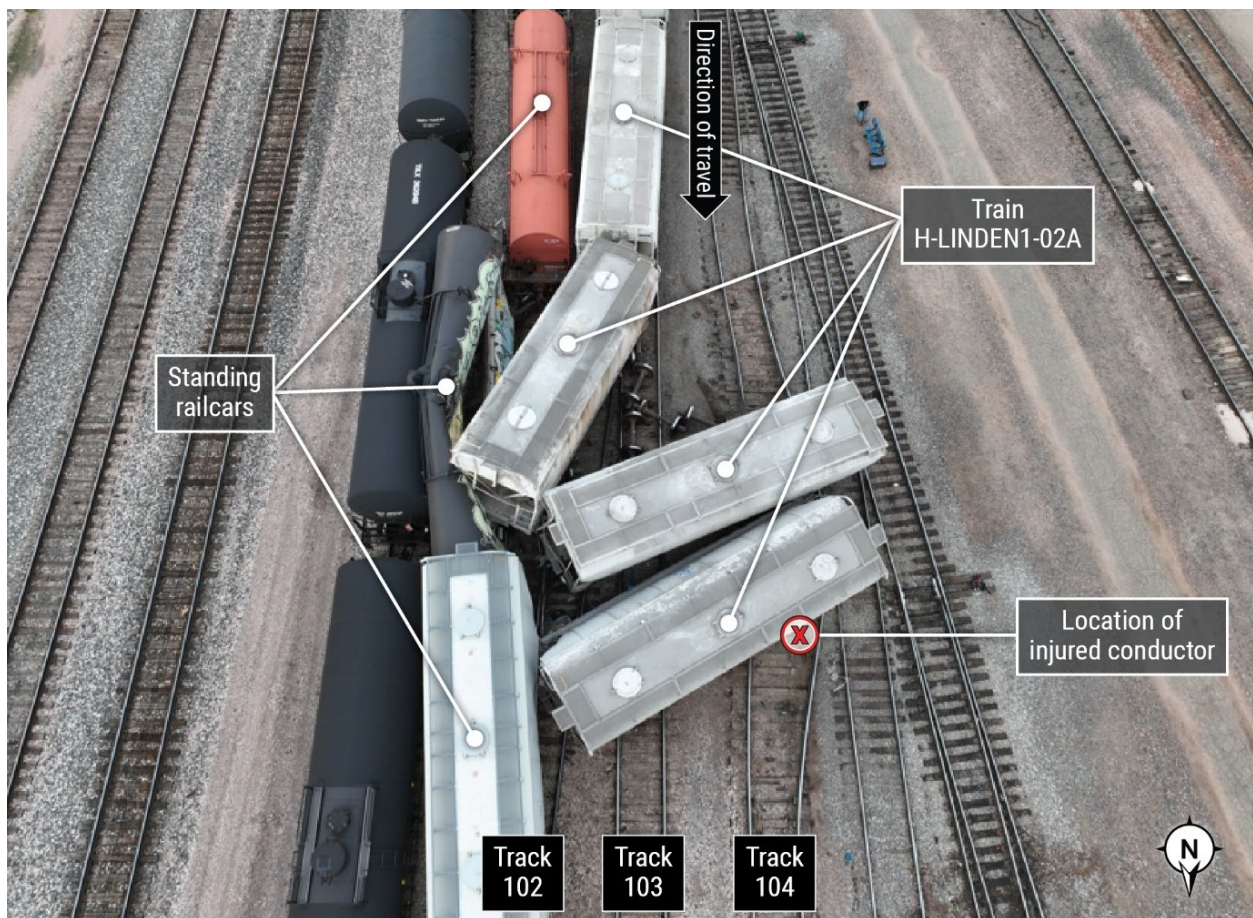
**Figure 3.** Railcars after the 2025 collision and conductor injury in Denver, Colorado. (Photo: BNSF.)

During our investigation of the Denver accident, which was caused by a misaligned switch on the track into which the BNSF crew was shoving their train, the NTSB interviewed the yardmaster on duty at the time of the derailment. He described the general nature of what BNSF called “job safety briefings” at that location, noting that the average briefing “can happen on the lead, it can happen on a locomotive, it can happen in a crew room, it happens anywhere.” He noted that in general, these briefings address the functions of the job, relevant rules, planned movements and tasks, and conditions to watch for, like water on the track. He further clarified that he

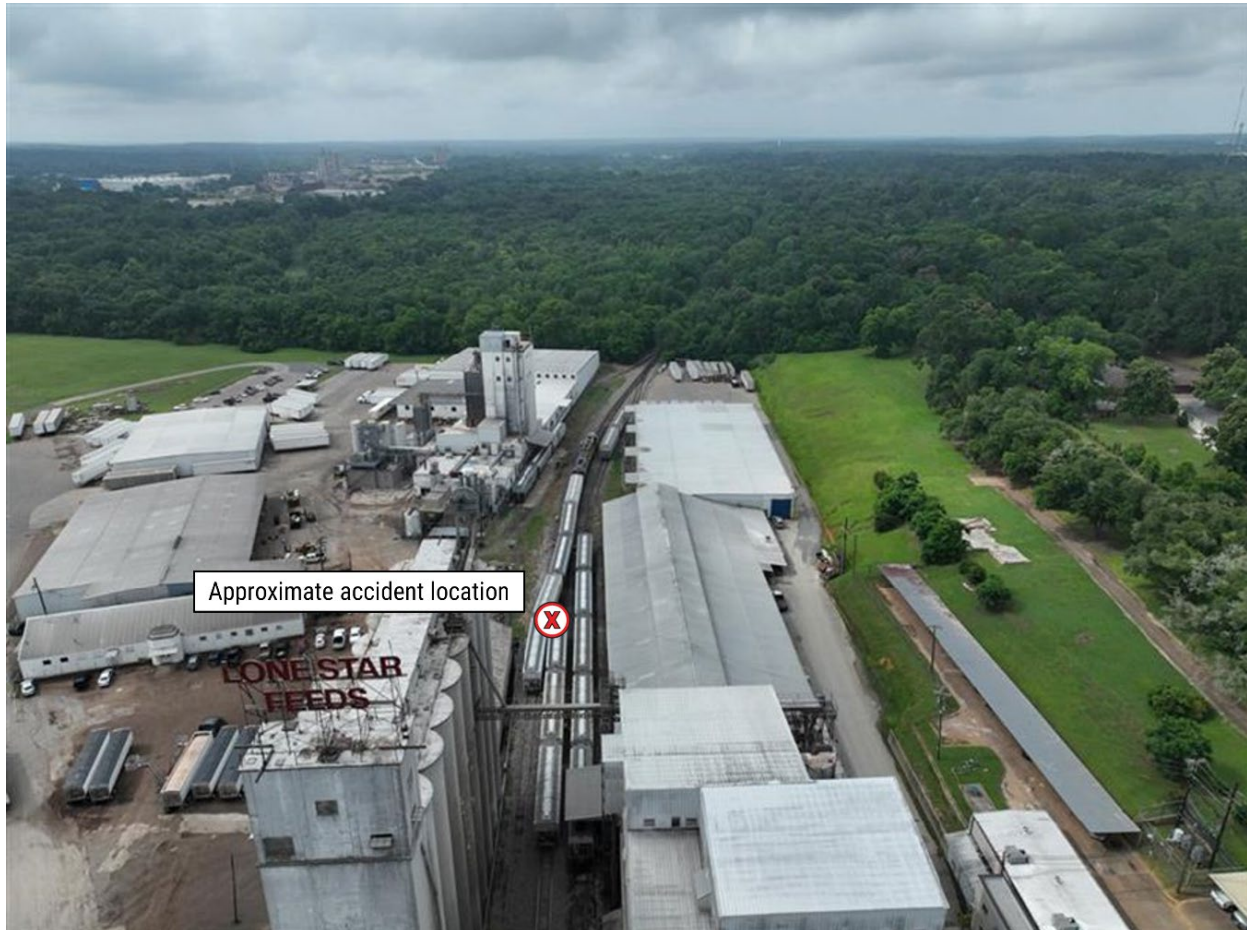
control. He was fatally injured when his train struck railcars that were fouling the track.<sup>8</sup> In 2024 in Melrose Park, Illinois, a UP conductor positioned on the leading end of a tank car during a shoving movement was pinned between colliding trains and fatally injured. In 2025 in Nacogdoches, Texas, a UP conductor was riding the lead railcar during a shoving movement when his train sideswiped a railcar fouling an adjacent yard track, causing fatal injuries. (See figure 4.)

**Figure 4.** Accident site in Nacogdoches, Texas.

In many of our investigations, we have observed that employees rode equipment without supervisory objection, even when safer methods of point protection were available. In our investigation of the Nacogdoches accident, we interviewed the trainmaster who had worked with the fatally injured conductor on the day of the accident. He noted that sometimes the conductor would ride railcars for short distances, adding that in those cases it would have been easier to walk: "There's a certain point to where it's faster walking than it is riding, and there's certain times where it's faster ... riding than [walking]." In this case, though the trainmaster stated he did not consider riding equipment for short distances to be an efficient use of time, he did not discourage the practice.
