Railroad Investigation Report RIR-23-13

Watco Dock and Rail, L.L.C.

Employee Fatality

Houston, Texas
October 29, 2021

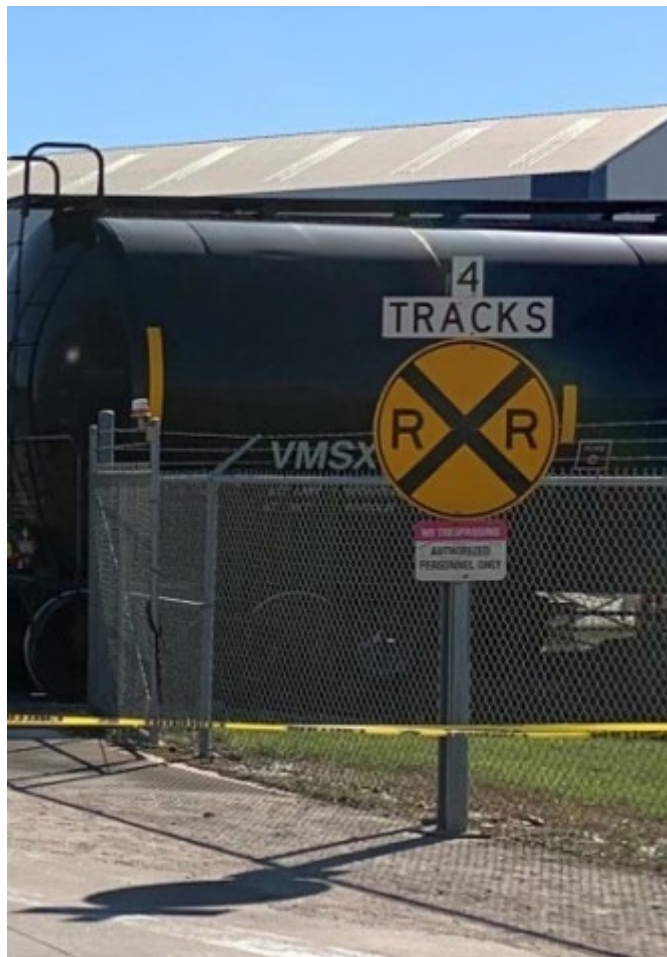
The grade crossing was equipped with passive warning devices including pavement markings and an advance warning sign facing Federal Road. (See figure 3.) The grade crossing was not equipped with active warning devices (such as lights that flash only when a train is approaching or occupying a crossing) or crossing gates, nor was an employee stationed at the crossing to protect it.

Figure 3. Highway-railroad grade crossing at Greens Port Industrial Park (Source: Federal Railroad Administration.)
