Railroad Investigation Report RIR-23-14

Norfolk Southern Railway

Contract Roadway Worker Fatality

Reed, Pennsylvania
December 8, 2021

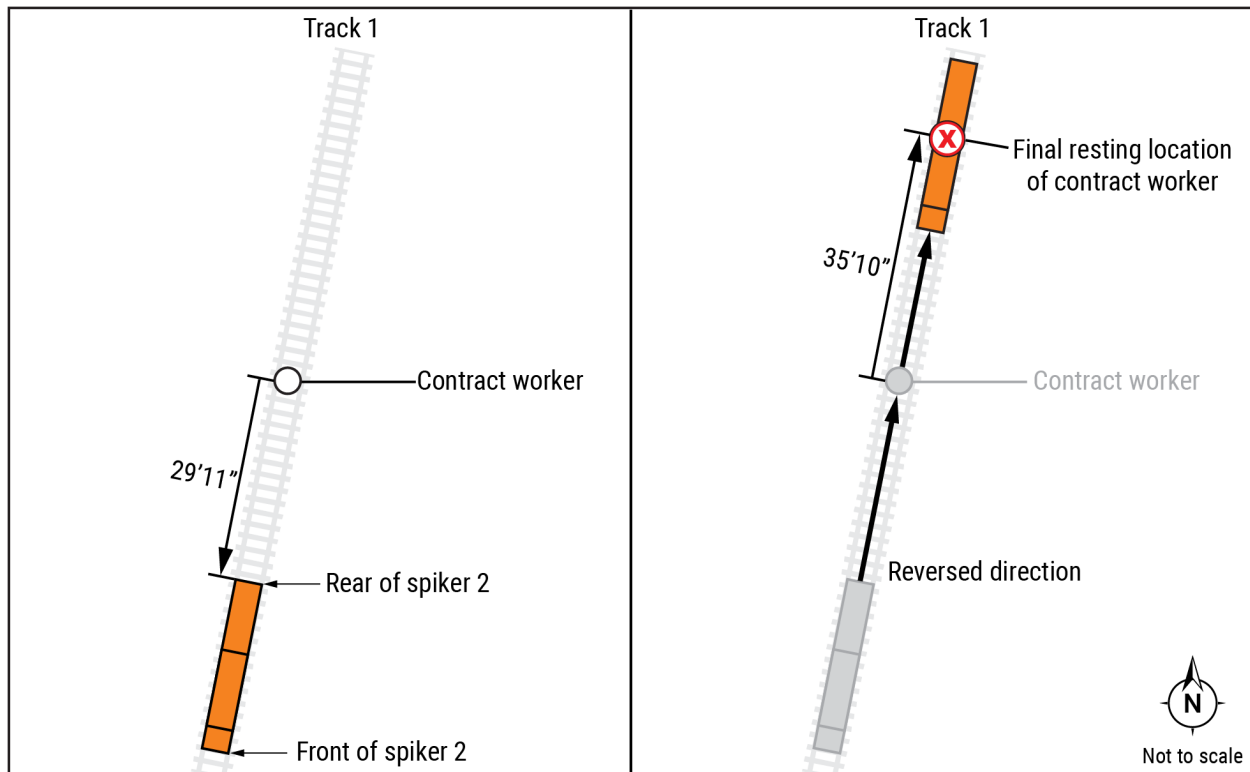
Figure 1. Positions of Spiker 2 and contract worker before and after the accident.

Figure 1 shows the accident location before impact, with the contract worker located 29 feet 11 inches north of the rear of Spiker 2 on the main track 1, and the final resting location of the contract worker beneath Spiker 2, 35 feet and 10 inches north of his original location as measured during postaccident site examinations.

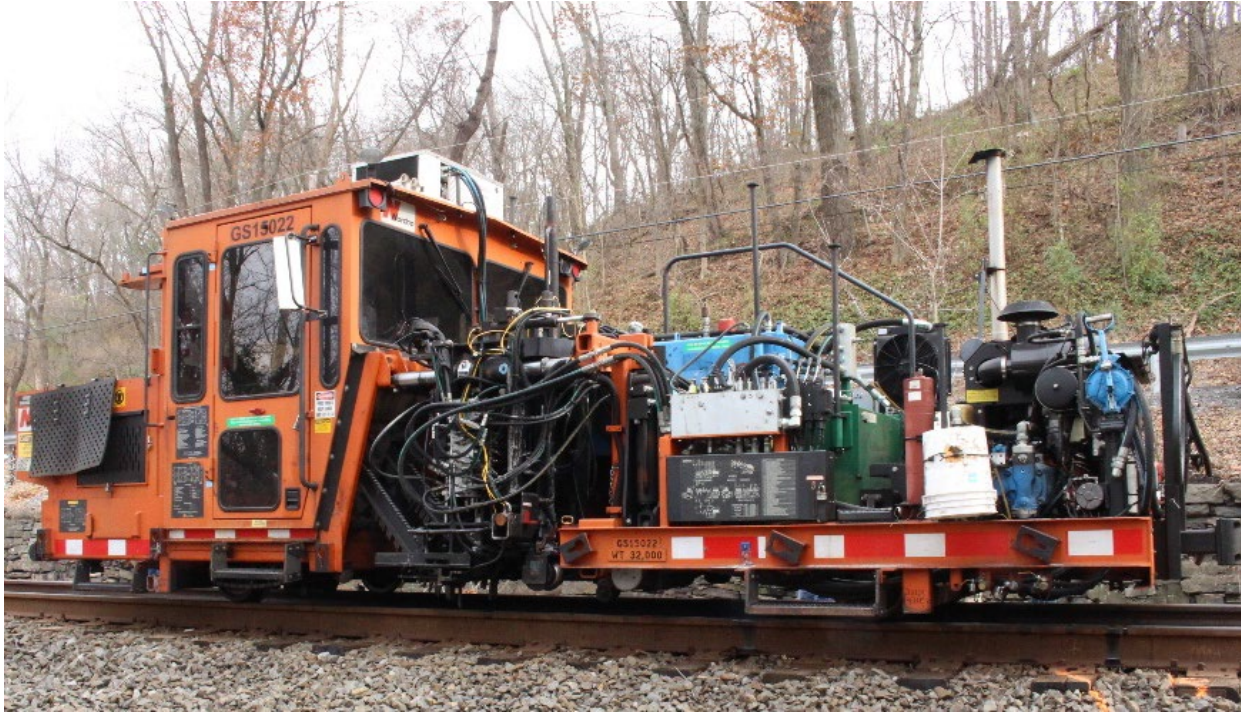
Figure 2. Spiker 2 at the accident scene. The front of the spiker is to the right.

Spiker 2 was built in December 2015. (See figure 2.) These spikers were rail-bound machines that used opposing, hydraulically driven, high-impact spiking hammers to drive spikes into place on a railroad track. The spikes were fed from a bin at the rear of the cab into a loading mechanism. The enclosed, climate-controlled cab

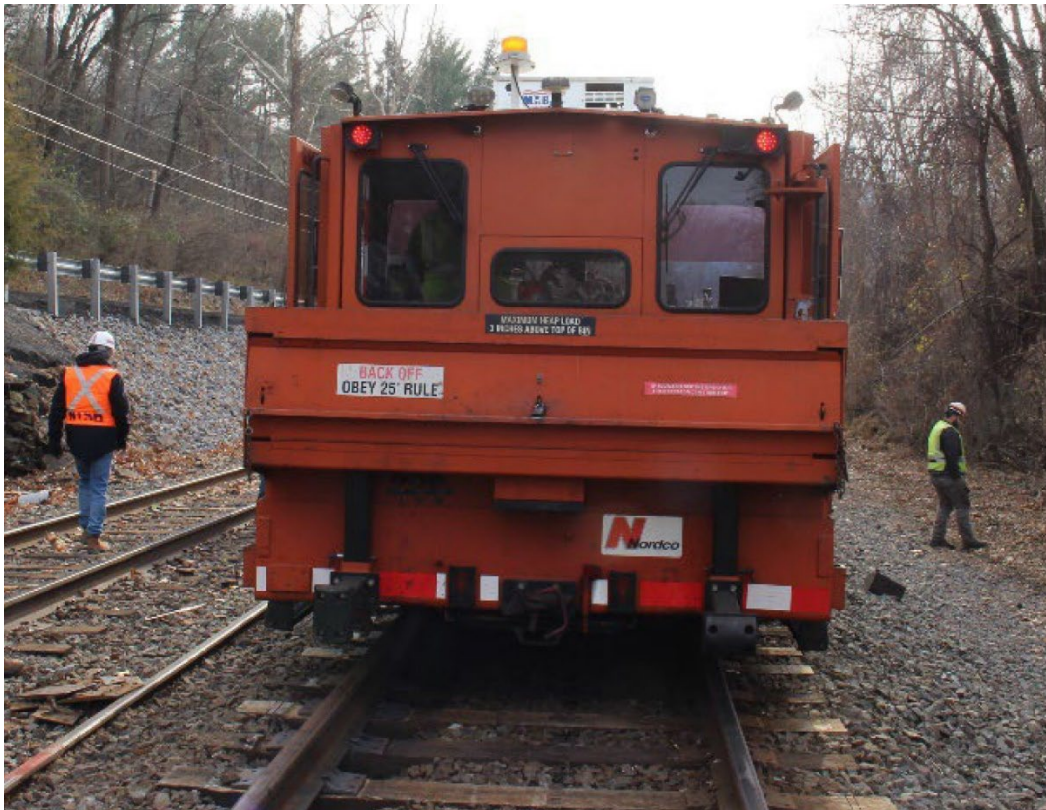
Figure 3. Standoff warning sign on the rear of Spiker 2.

The spikers were also equipped with rear view mirrors as required by FRA regulations, one on each side of the machine.⁸ Warning signs affixed to the rear of the spikers alerted personnel to the standoff distance of 25 feet (NS 2019). (See figure 3.) According to the NS rail gang supervisor, some RMMs in the NS fleet are equipped with backup video cameras. The spikers working on the day of the accident were not.

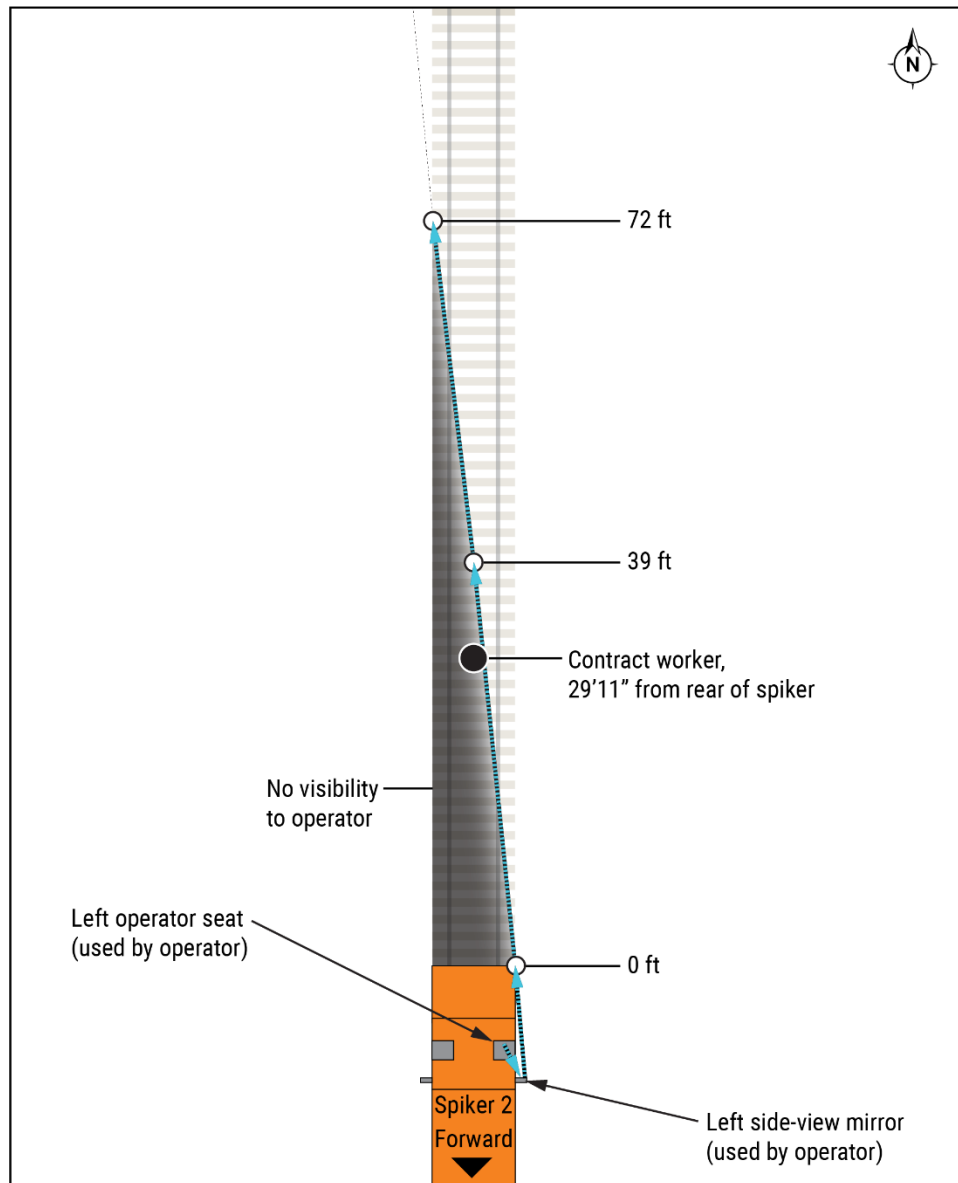
Figure 4. Diagram of sight distance observations for Spiker 2.

The white dots in figure 4 represent the points at which Subject 2, standing in three locations on the track, first became visible to Subject 1. This point was 72 feet from the rear of Spiker 2 on the left side of the track, 39 feet from Spiker 2 in the center of the track, and 0 feet from Spiker 2 on the right side of the track. The black dot represents the position of the contract worker just before the accident sequence.

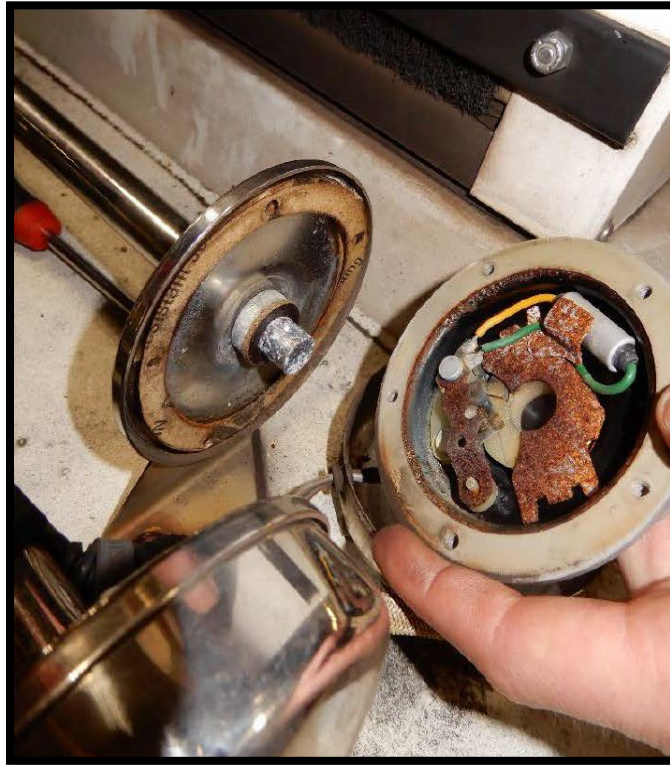
Figure 5. Internal components of a nonworking horn trumpet.

The NTSB disassembled the roof-mounted horn trumpets and observed that the internal components of the three nonworking trumpets were heavily corroded and rusted. Figure 5 shows the condition of the internal components of one of the nonworking trumpets. When new trumpets were connected to Spiker 2, they functioned correctly.

A review of Spiker 2 maintenance records from January to October 2021 showed that the inoperable roof-mounted trumpets had not been detected, documented, or remediated.

Audible warning devices are critical in a working environment that includes heavy equipment, as workers rely on these devices to know when it is safe to work and when it is not. Postaccident testing of Spiker 2 revealed that three of the four roof-mounted trumpets were rusted and heavily corroded and incapable of emitting any sound. Thus, the horn would not have been audible above the ambient noise of the working spikers at the time of the accident, providing no warning for the worker, who was standing more than 25 feet from the rear of the spiker.
