Apply SOFA Operating Recommendations – Recognize Special Switching Hazards

Switching Fatality and Severe Injury Update 2007 Third Quarter

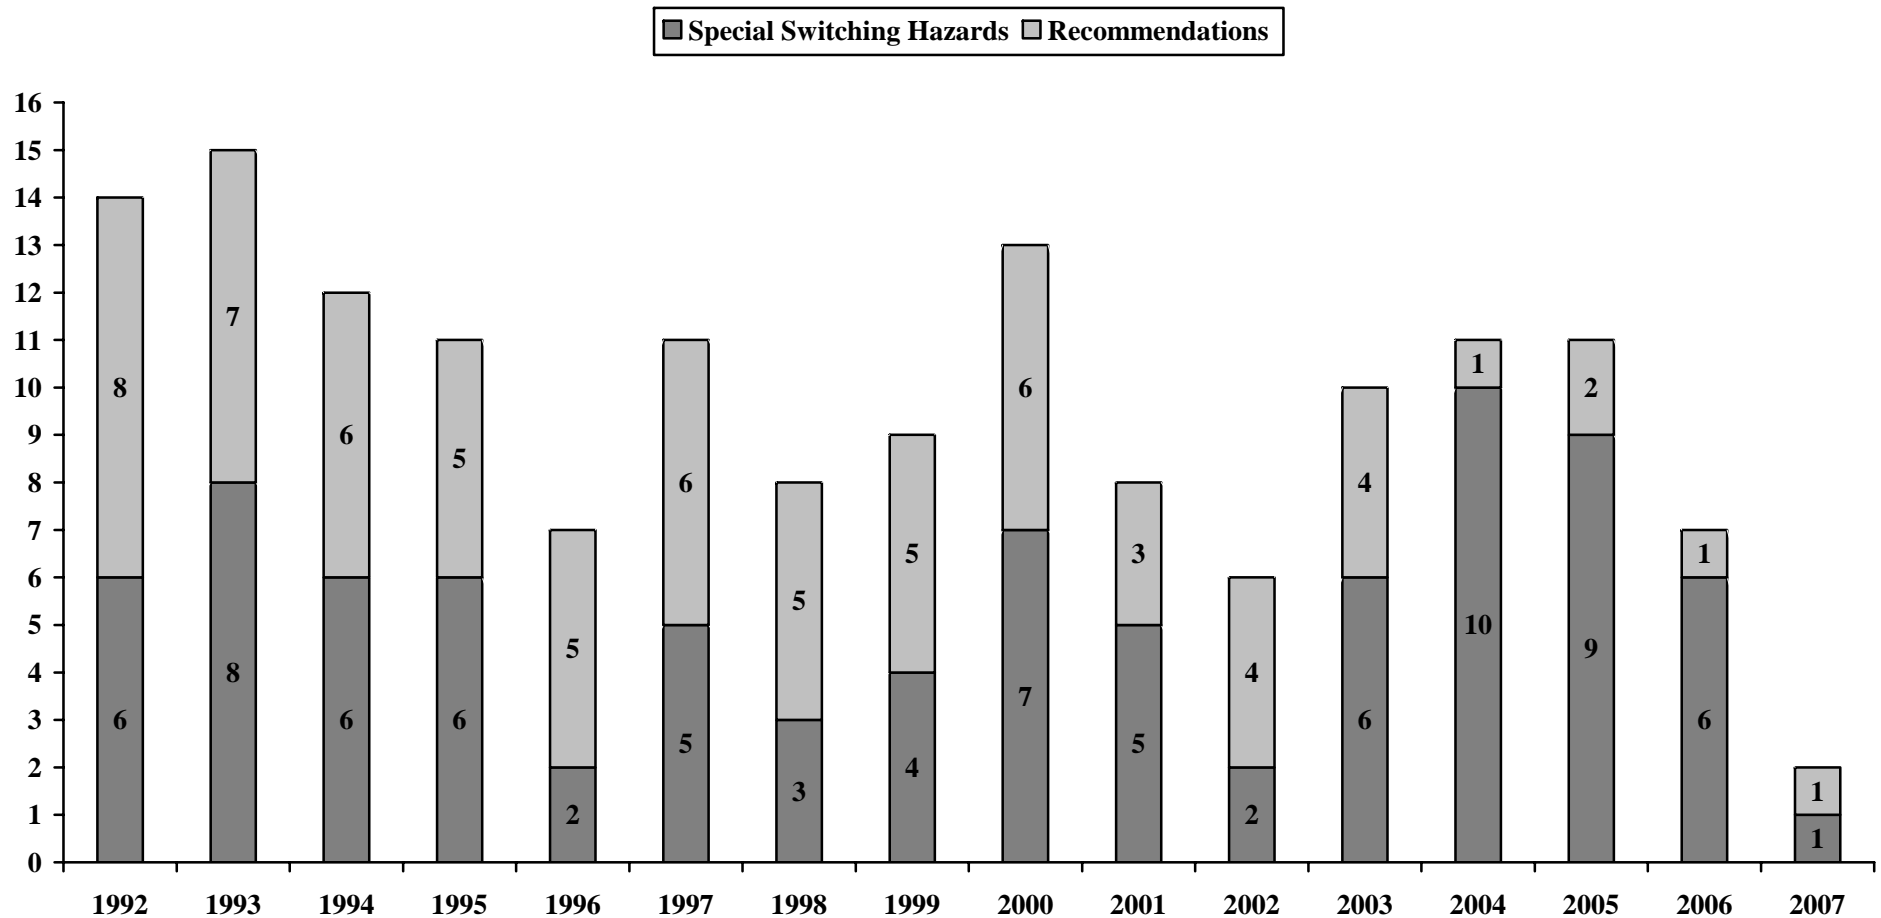
155 Switching Fatalities Classified by Type: Involving Operating Recommendations and Involving only Special Switching Hazards January 1, 1992 through August 15, 2007

Switching Fatalities involving Operating Recommendations have declined absolutely, and as a proportion of all Fatalities. These declines are particularly evident in the years 2004 through 2006. (Fatalities for 2007 are for the first 8.5 months.) Special Switching Hazards are now the more prevalent Fatality type. These Hazards are described on page 7.
