Don't Get Hurt...When You Think Not
Applying SOFA Operating Recommendations; Recognizing Special Switching Hazards
Reduces Risk When Least Expected

Switching Fatality and Severe Injury Update – 2009 Second Quarter

Preliminary Summaries of 6 Switching Fatalities in 2009

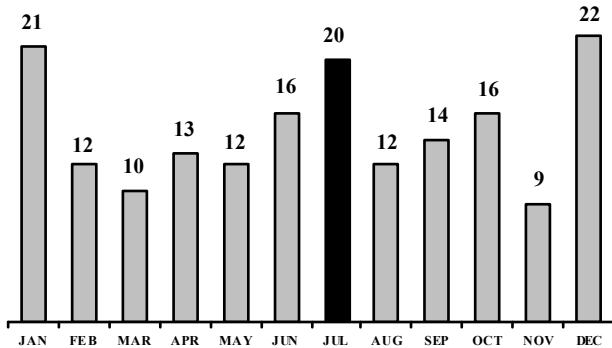
177 Switching Fatalities: by Month
January 1, 1992 through June 4, 2009

While upcoming July historically is a high month for Switching Fatalities, THERE IS ALWAYS RISK

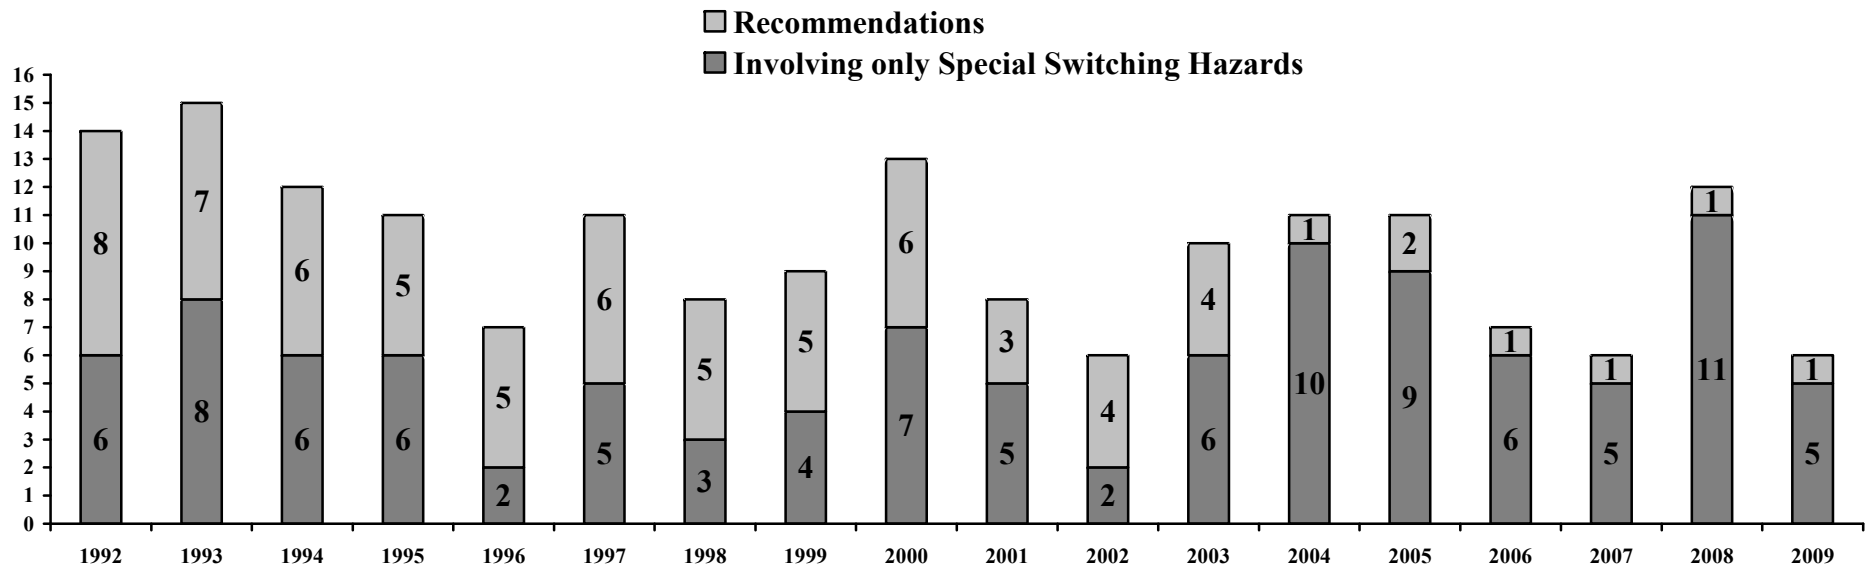
The SOFA Working Group is now reviewing recent Switching Fatalities with emphasis on Special Switching Hazards. While Fatalities related to Operating Recommendations have declined in recent years, the number of Hazard-related Fatalities has not.

177 Switching Fatalities Classified by Type: Involving Operating Recommendations; and Involving only Special Switching Hazards, January 1, 1992 through June 4, 2009

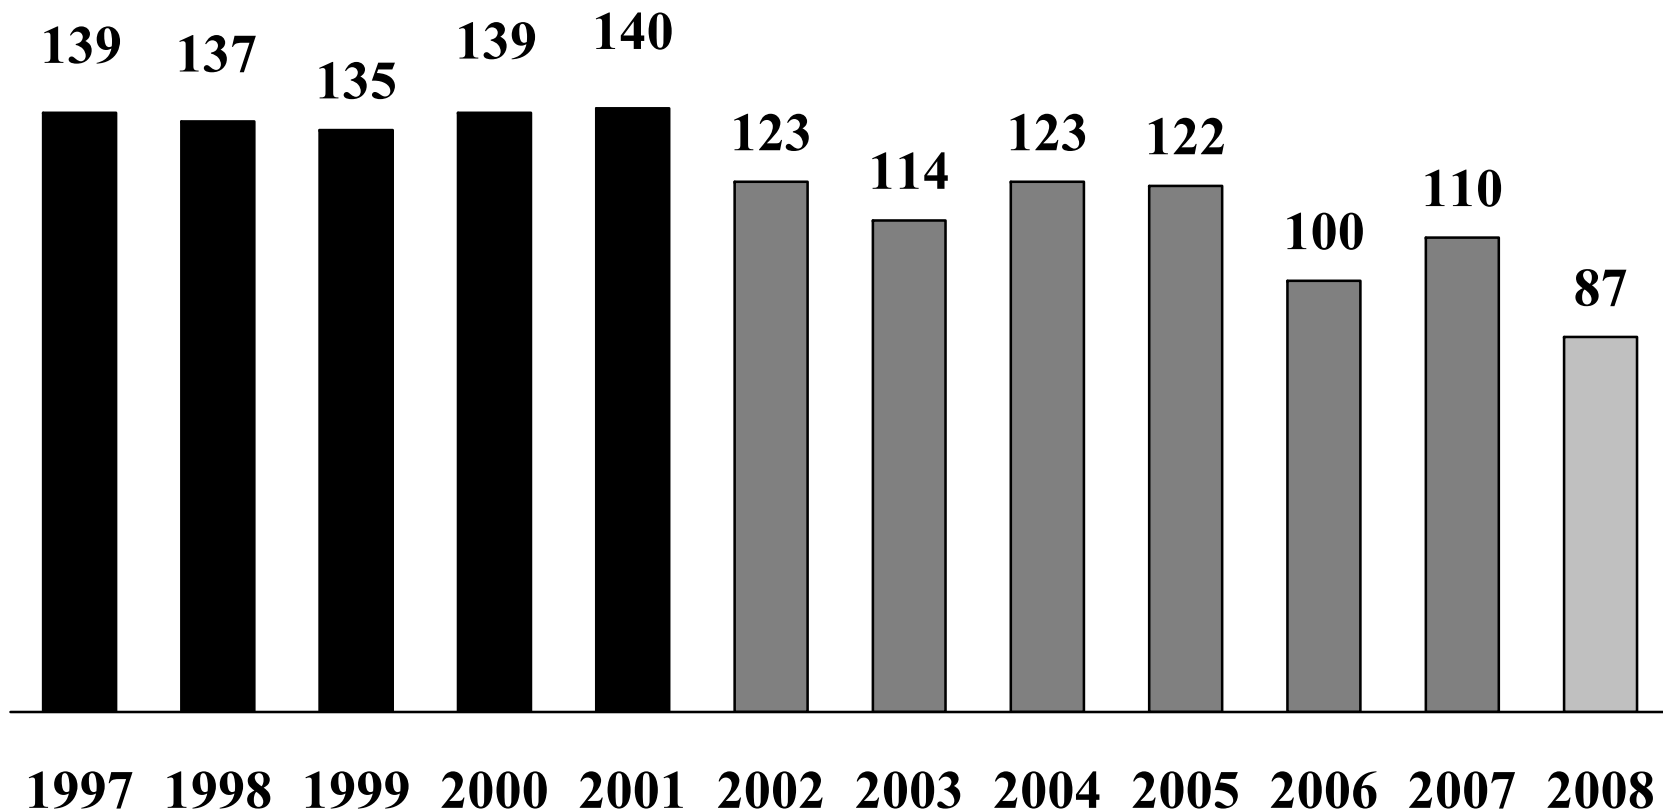
Declines in SOFA-defined Severe Injuries, 1997 through 2008

- Beginning in 2002, Severe Injuries have declined, although not consistently, year-to-year
- The 87 Severe Injuries in 2008 are the lowest historically in the 12-year period
- Also, in the first quarter of 2009, Severe Injuries are historically low (shown on *page 8*)
